# Manhole Inspection Summary

## Manhole # S33GG1018MH

Insp Date: **2/5/07 9:21 AM**

**Location** Address: **3959 CLOVERHILL RD** Cross Street: **HIGHFIELD RD**

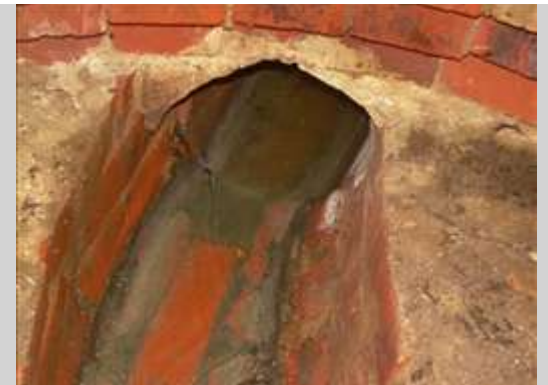
### 8 in. Circular Gravity Sewer Pipe In @ 7 O'Clock

Rod and Bar (Angled)

Infiltration: **None** Pipe Seal Cond: **Sound**
